**Flood Control Project Maintenance
Levee Inspections**
LMA District Cover Sheet
Spring 2010 Levee Inspection Results

Levee District No. 0001 (Glenn County)

Levee Inspection Report By Mile - Spring 2010

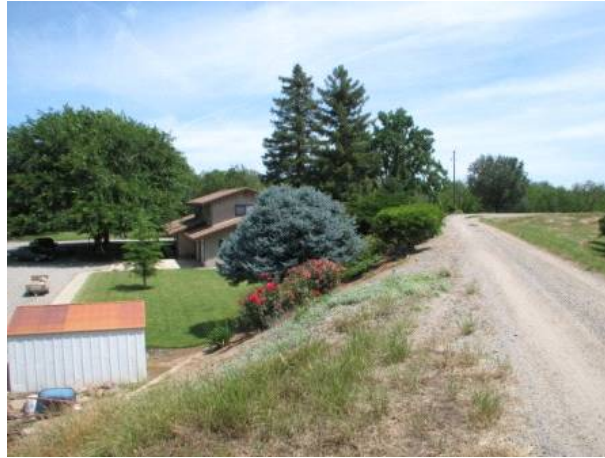
Levee Mile Report Line	6
Start Levee Mile	1.35
End Levee Mile	1.39
Location	Land Side
Category	Earthen Levee
Item	Encroachments

View of the permitted landscape on the landside slope of the levee.

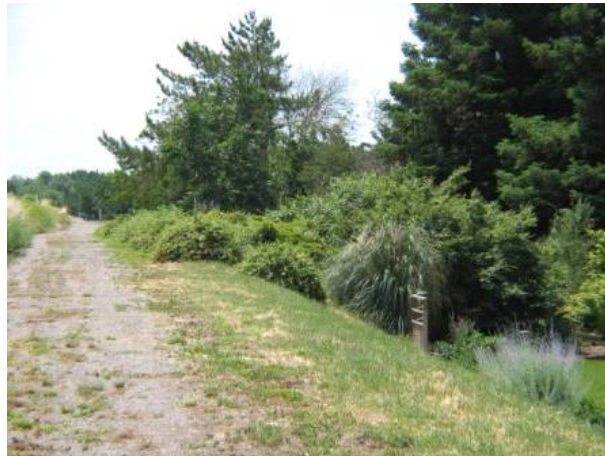
Levee Mile Report Line	30
Start Levee Mile	6.39
End Levee Mile	6.42
Location	Land Side
Category	Earthen Levee
Item	Encroachments

View of the permitted landscape along the landside slope.

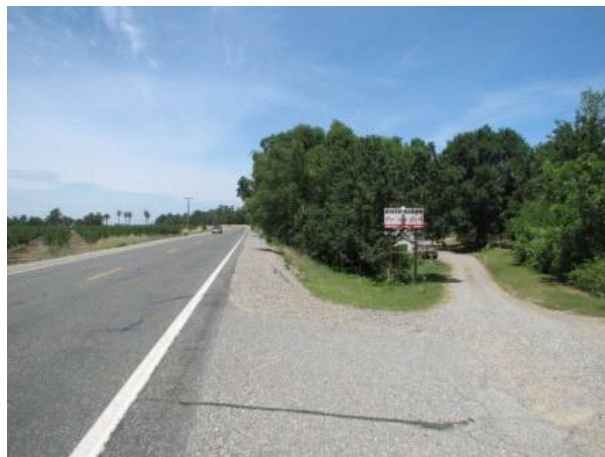
Levee Mile Report Line	33
Start Levee Mile	8.17
End Levee Mile	8.28
Location	Water Side
Category	Earthen Levee
Item	Trim / Thin Trees

View of the trees and vegetation along the waterside slope of the levee.
